## 9.10 METALSTUD EN MATERIAALSTAAT

Harm Vos  
Po3BB  
Jelle Broeks  
Project 9  
03-06-2024

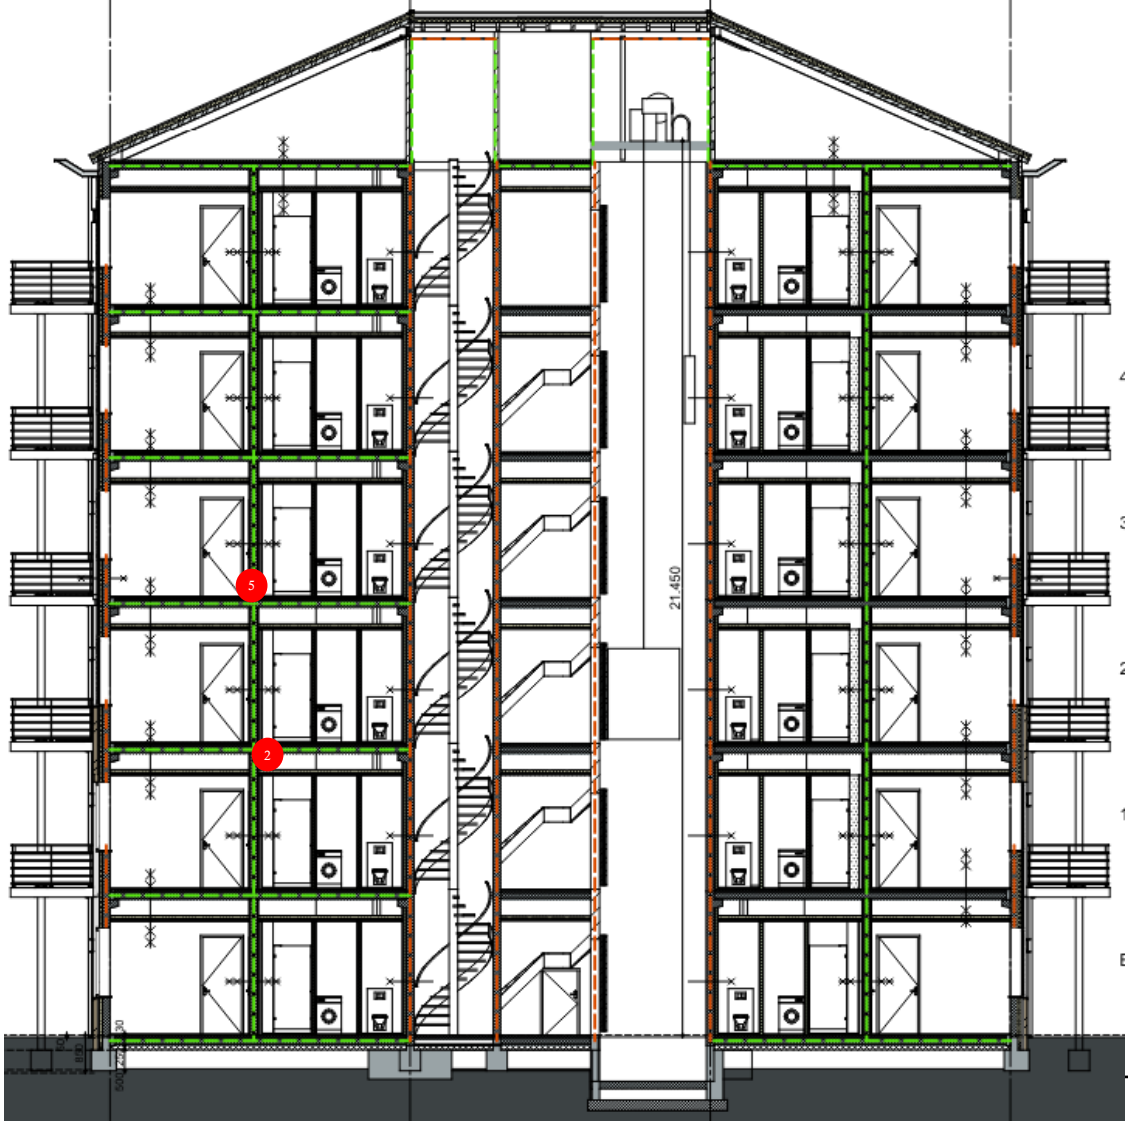
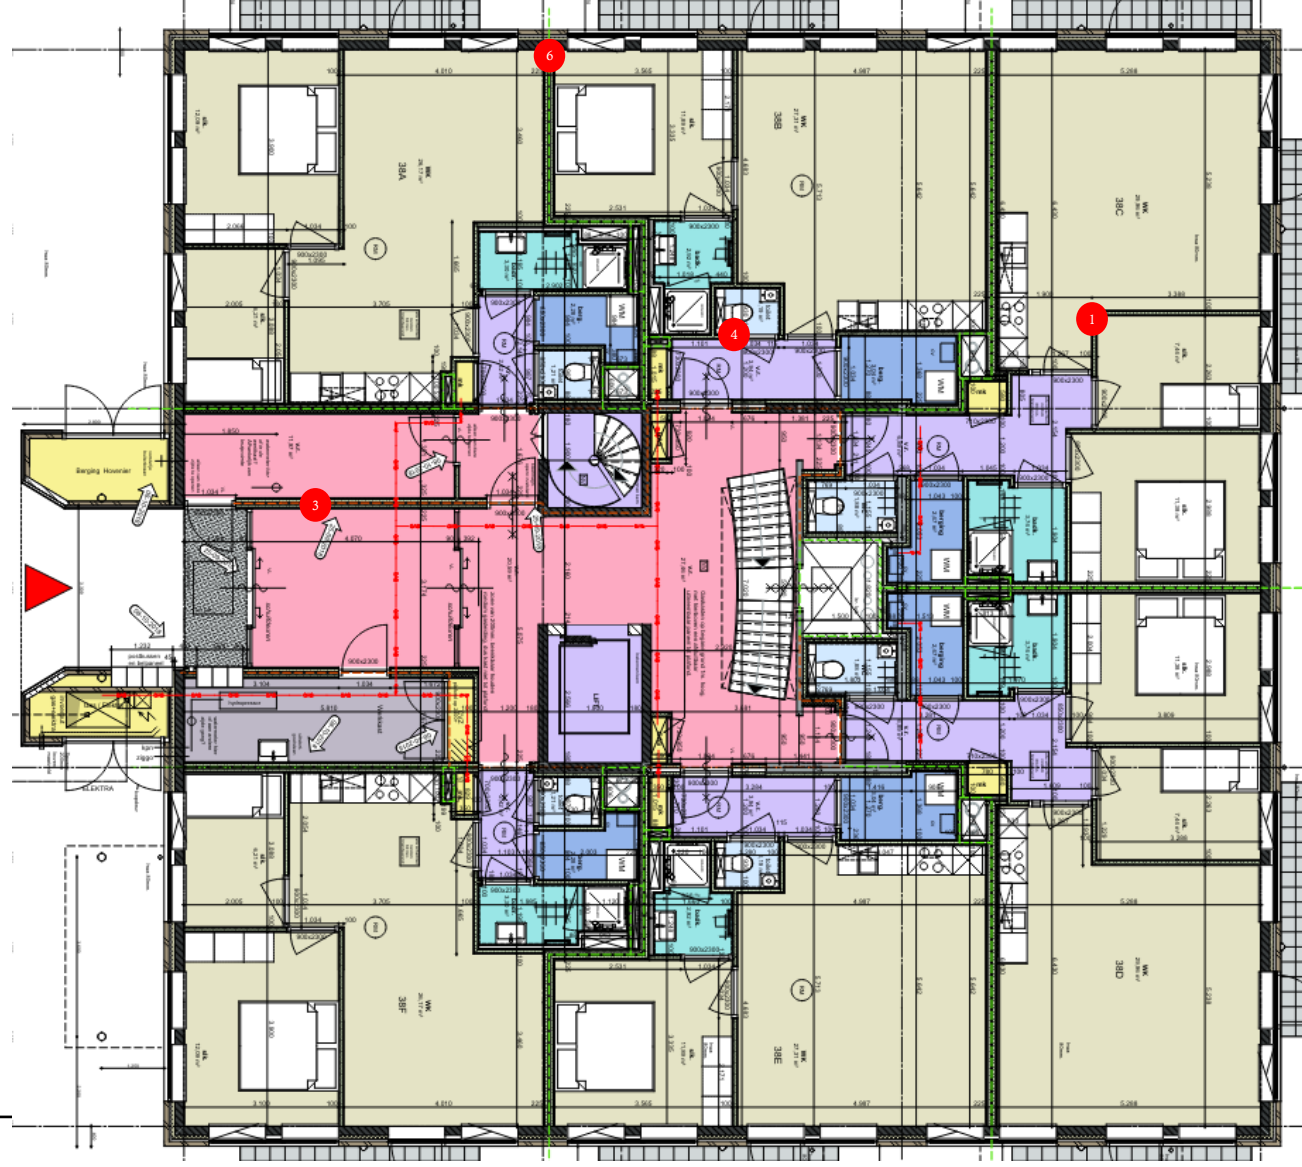
# DETAIL 1

- Standaard Binnenwand

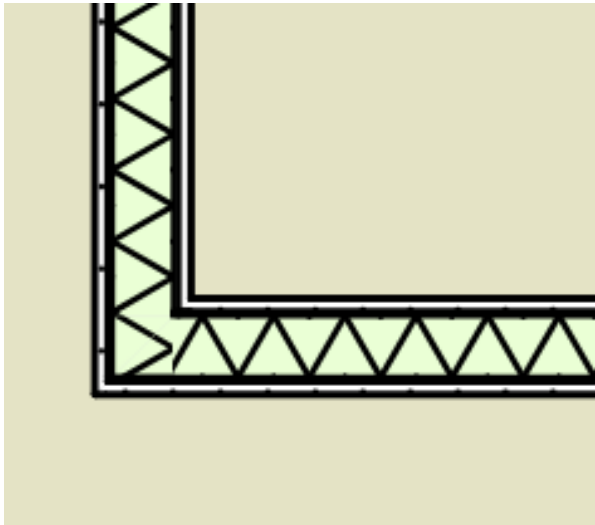
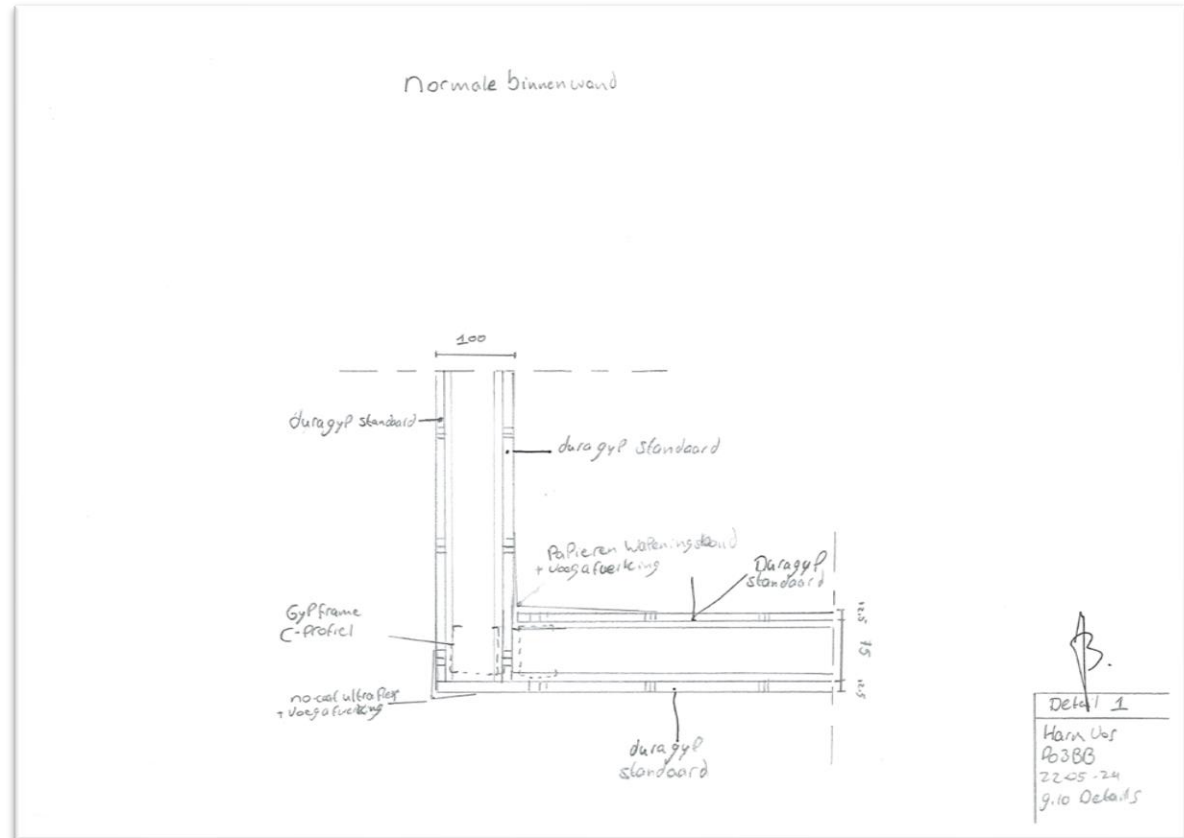
# DETAIL 2

- Plafond
- Brandwerend

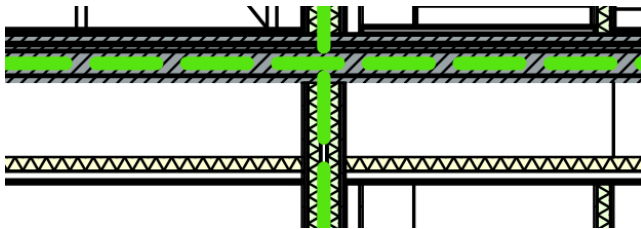
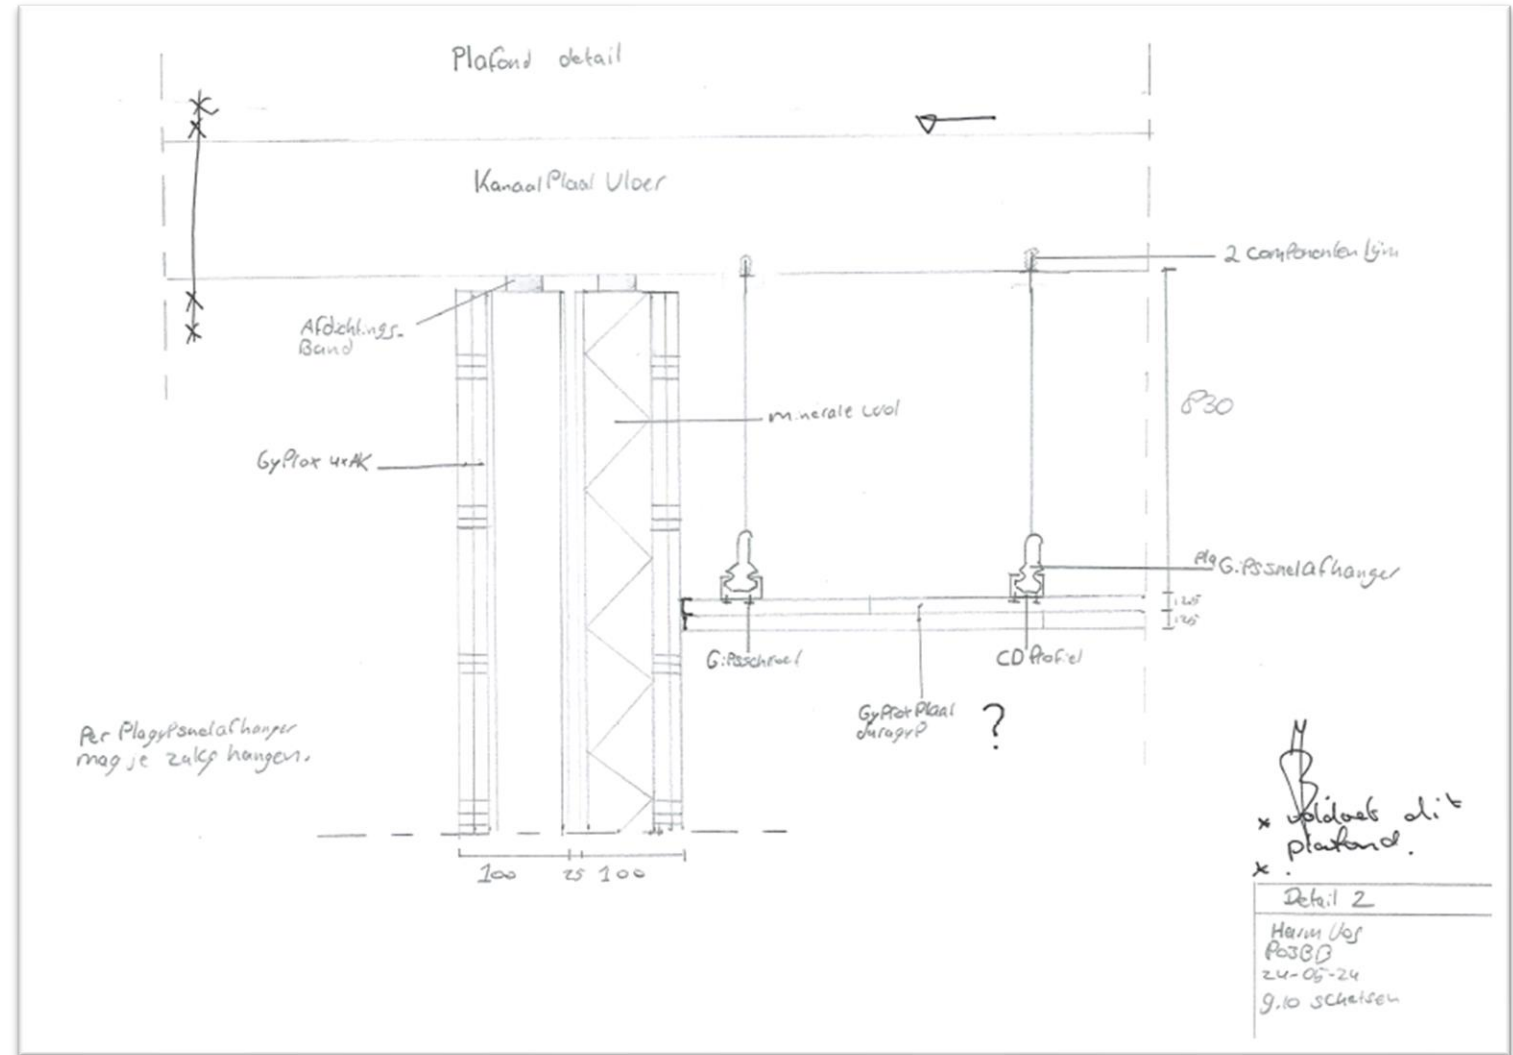
# DETAIL 3

- Brandwerend 60 min
- Stootvast

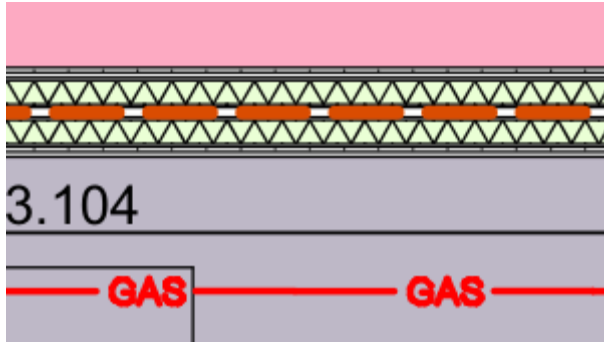
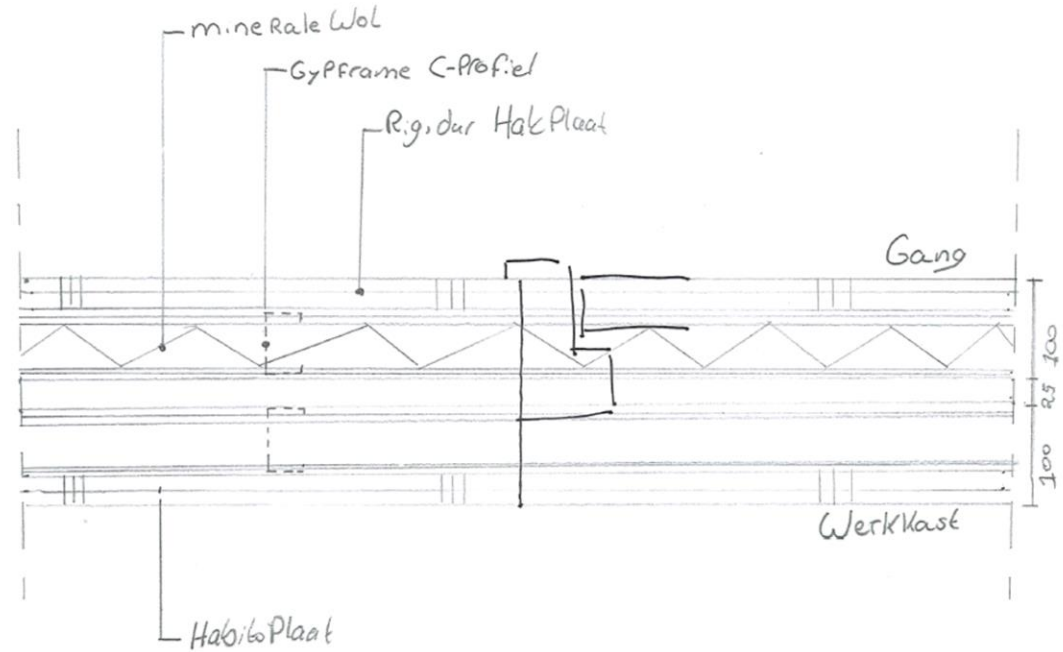
# DETAIL 4

- Natte cellen

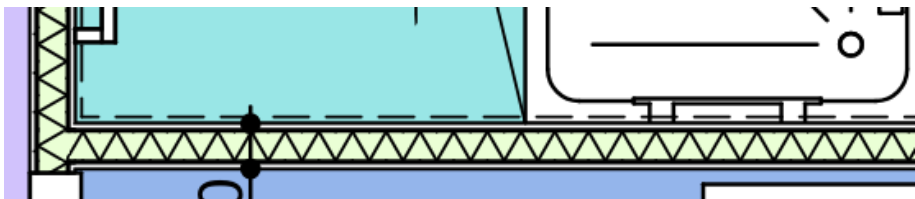
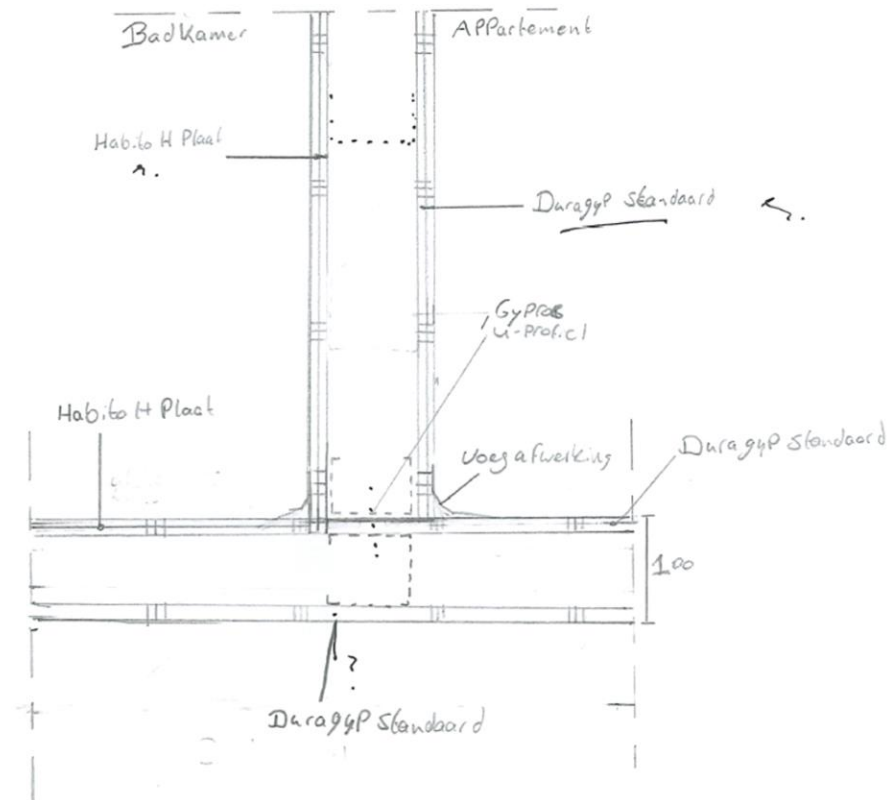
Detail 4

x profiel  
x

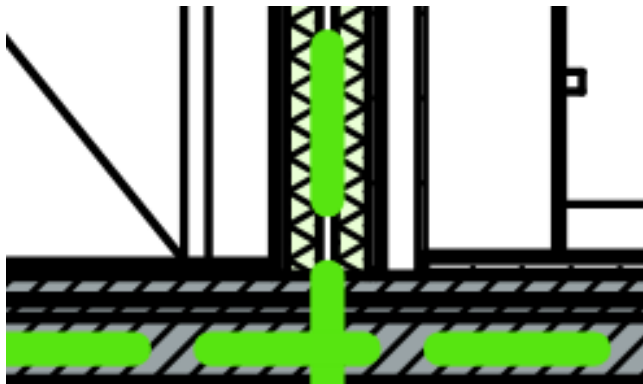
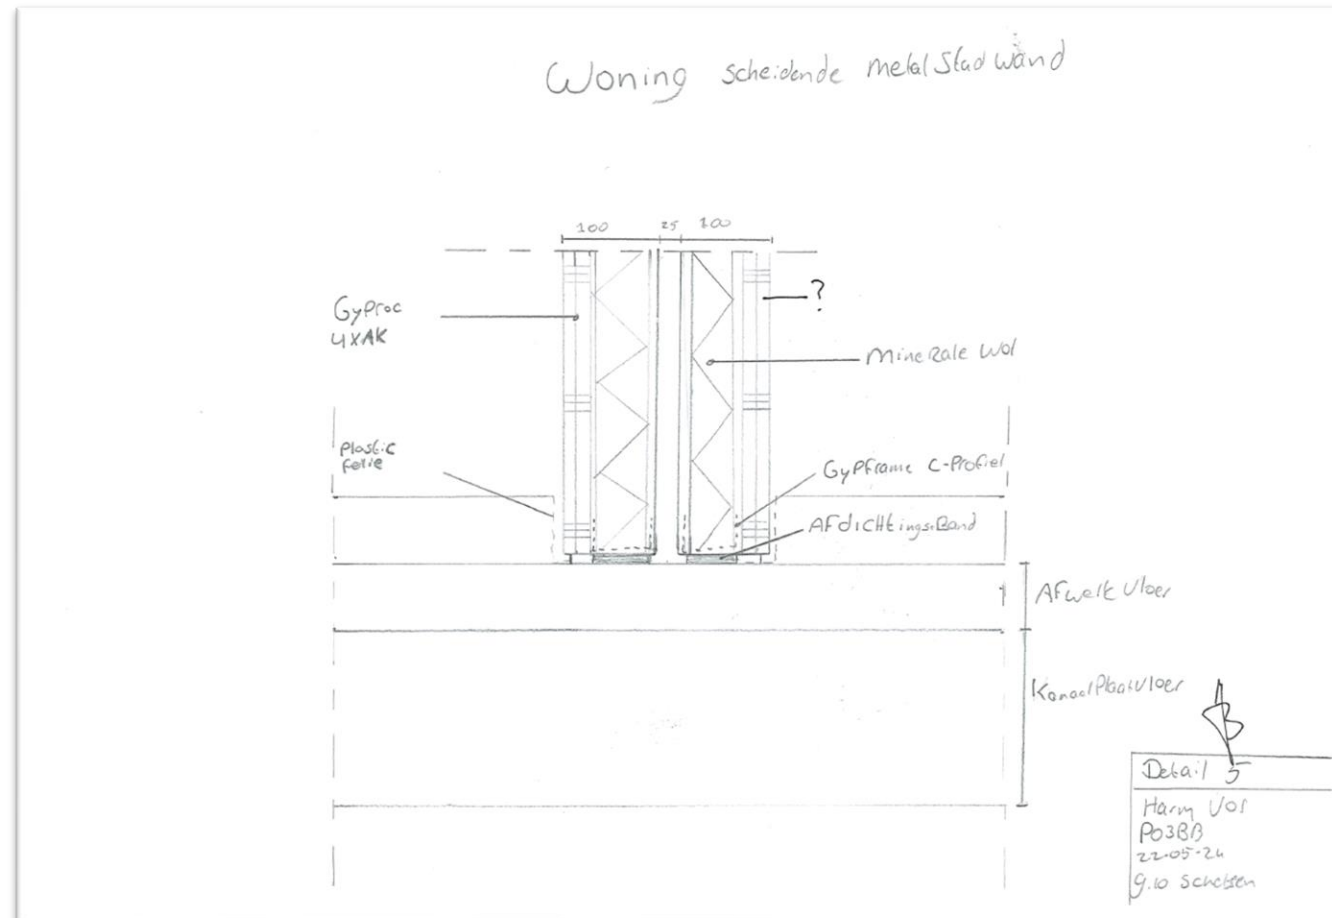
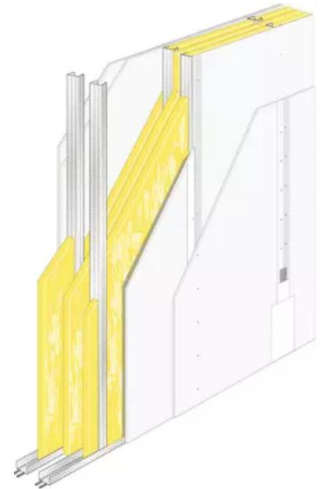
# DETAIL 5

- Dubbele wand
- 60 min brandwerend
- Stootvast

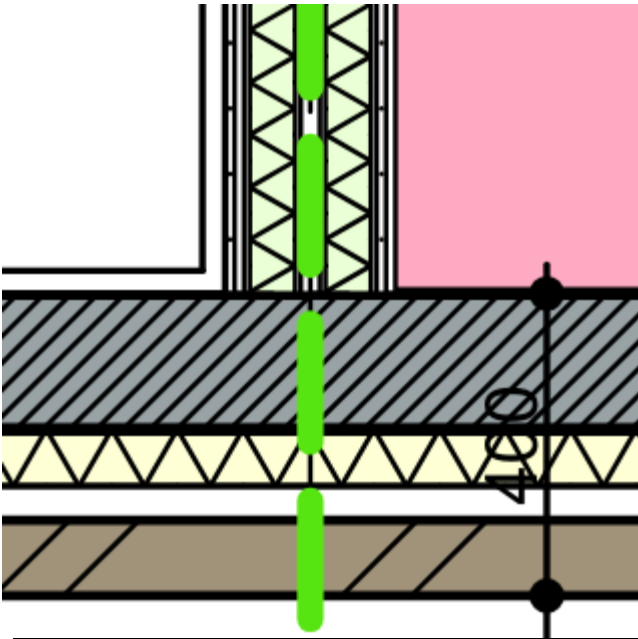
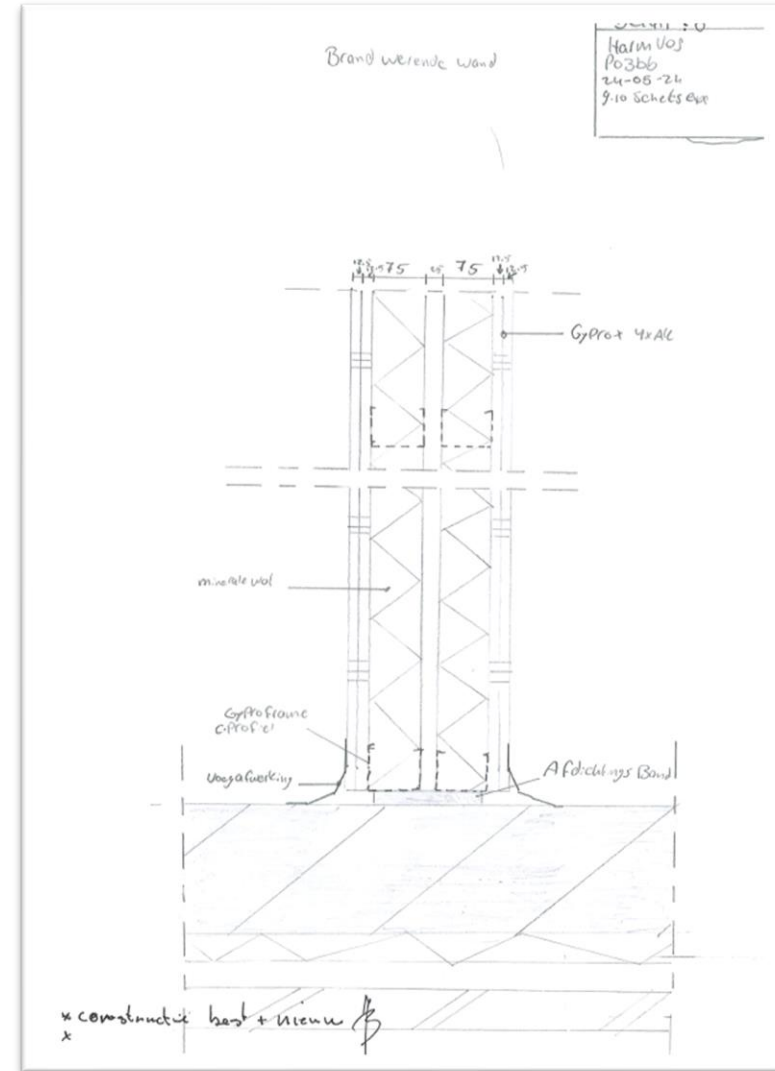
# DETAIL 6

- Woning scheidend
- 30 min brandwerend
- Geluidswerend
